**FINAL PROJECT REPORT**

**RD/RA OVERSIGHT  
PROJECT ASSISTANCE**

**HOWE VALLEY LANDFILL SITE  
HOWE VALLEY, HARDIN COUNTY, KENTUCKY**

**Work Assignment No. 17-4XN8**

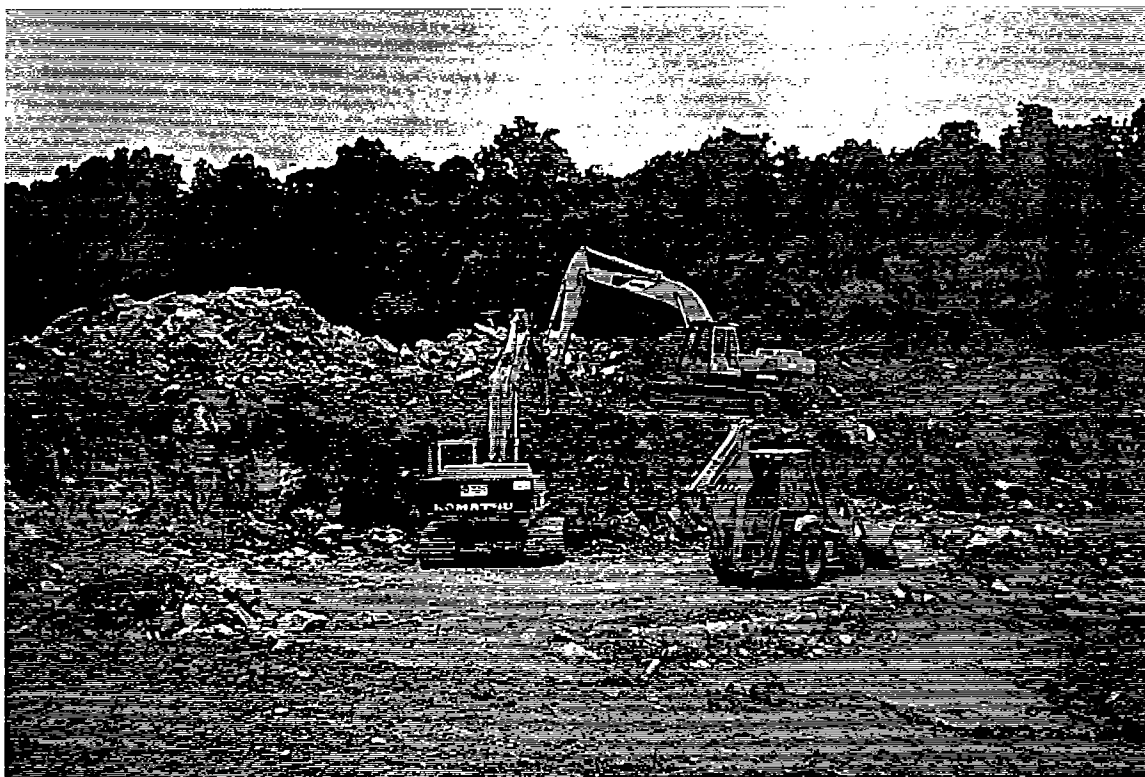
**Photograph No. 22**

**Description:** Excavation into limestone bedrock with hoe-ram attachment to investigate additional organic contamination.
